When the Earth Trembled, the Statues Fell

Edmundo Edwards, Raul Marchetti,
Leopoldo Dominichetti and Oscar Gonz  les-Ferr  n

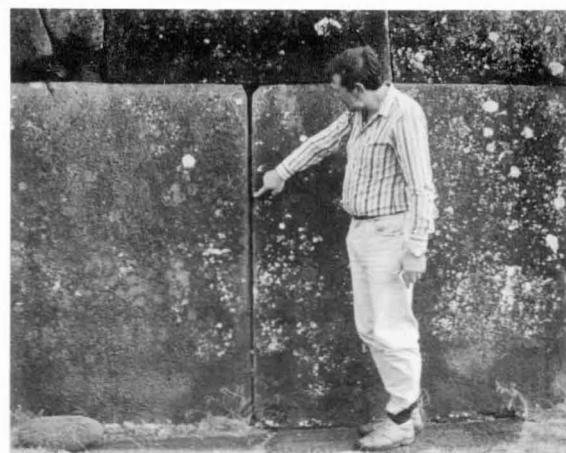
Figure 9. Edwards points out a separation in the sea wall at Ahu Vinapu which he suggests was caused by a violent earth movement.

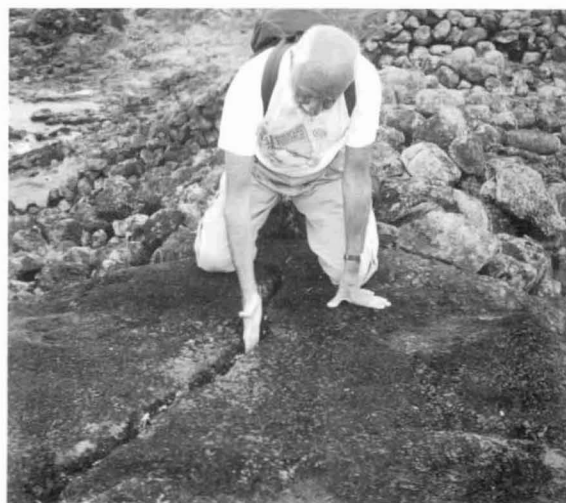
Figure 10. Statue pedestal at Ahu Te Tenga on the south coast with crack running through its center. It is postulated that this crack occurred as the result of an earthquake that caused a vertical movement. The statue's up and down motion broke the pedestal causing the statue to fall forward.
